NOTION ARCHAEOLOGICAL SURVEY, 2015

The second season of the Notion Archaeological Survey began on 18 May and ended on 15 June 2015. The average size of the staff was 13 persons. The director was Christopher Ratté. The Representative of the Ministry of Culture was Yalçın Yılmaz, for whose collegiality and helpfulness we are very grateful.

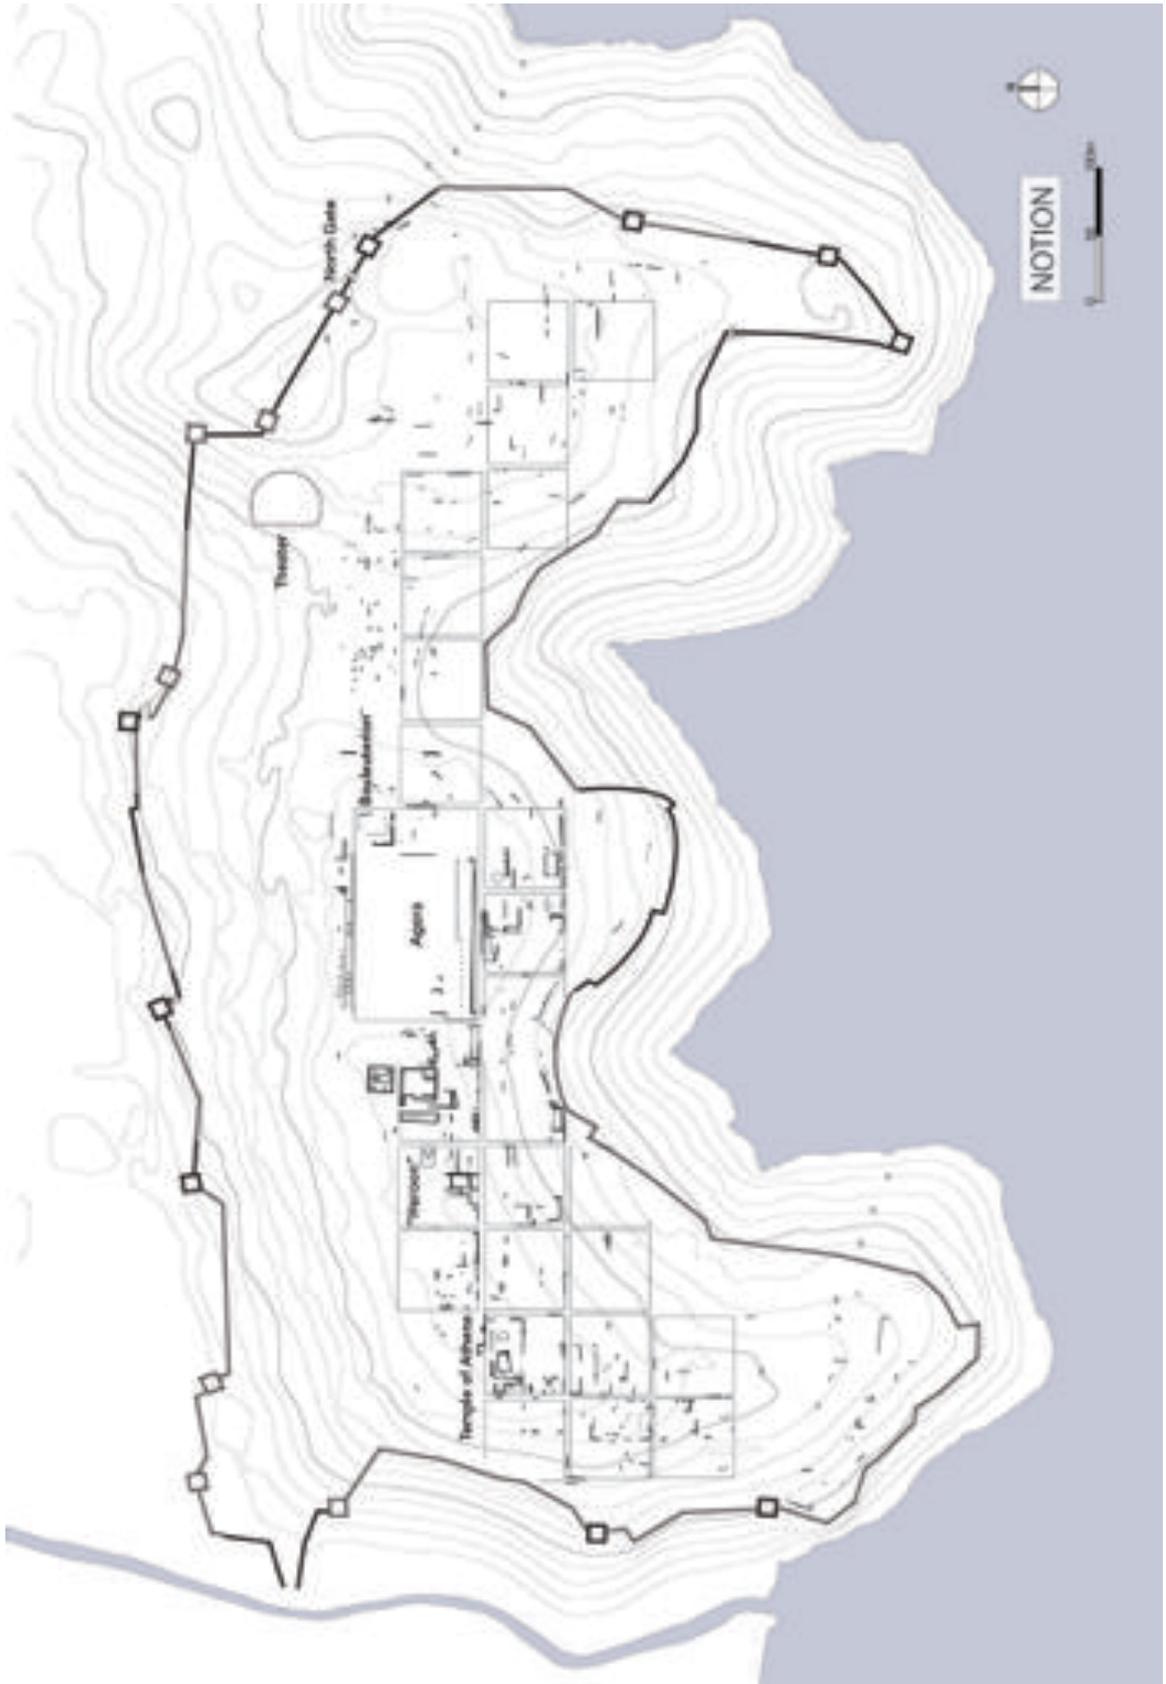
Fig. 1 Plan of site

Notion is a coastal site approximately 35 ha in area, surrounded by 3 km long fortification walls (see fig. 1). It occupies a ridge running east-west and parallel with the coast, framed by two promontories projecting southward into the Aegean Sea. It is clear from the visible remains and from satellite imagery that Notion is a grid-planned city, oriented according to the cardinal directions. The promontories and the north and south slopes of the site are occupied by residential areas. The central ridge is dominated by a chain of public and sacred building complexes, set on terraces largely carved out of the native rock. These include, from west to east, the Temple of Athena, the Heroon, the Agora, the Theater, and the so-called East Agora. The highest point on the site is the hill east of the Theater, which rises to an elevation of 85 m asl.

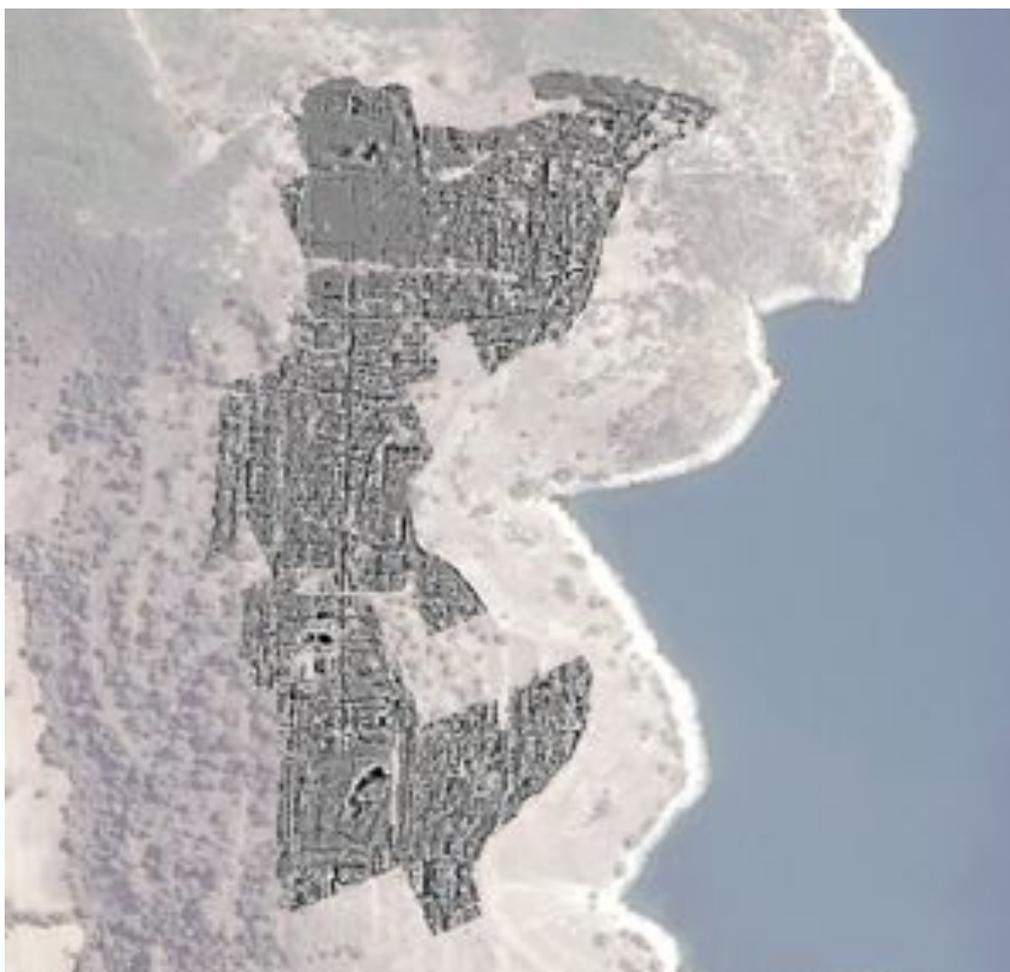
Fig. 2 Results of geophysical survey

As in 2014, the geophysical survey was based on a grid of 30 by 30 m squares oriented 30 degrees west of north. The grid was laid out with a Total Station, and a total of 67 full and 31 partial 30 X 30 m grid squares were surveyed with a Bartington Grad 601-2 fluxgate gradiometer. The geophysical survey was directed by G. Tucker, a doctoral student in archaeology at the University of Michigan. The results of the survey are shown in fig. 2. The geophysical survey has done much to clarify the street plan and domestic architecture of the city.

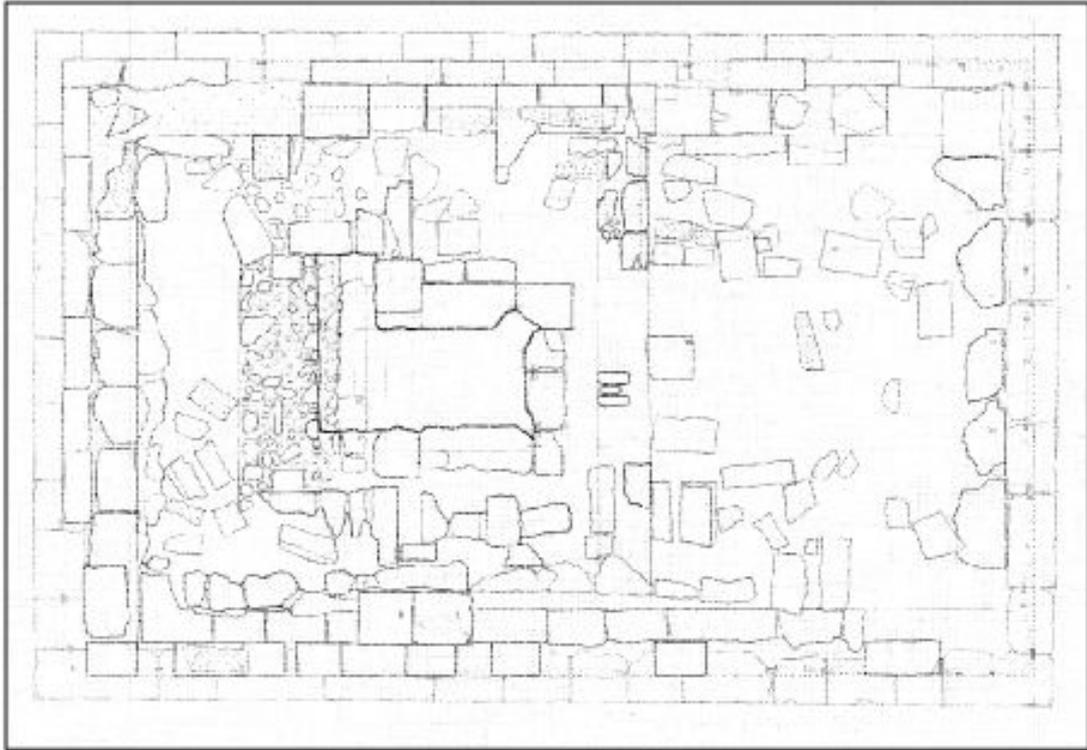
Plan of "Heroon"

Fig. 3 Plan of Heroon

Architectural documentation focused on the Heroon and Bouleuterion. Both buildings were cleaned and recorded in 1:50 state plans (see fig. 3). In addition, a program of systematic recording of all other visible architectural features was begun, focusing on the area around the Heroon and Agora and the terraced slopes to the south. Six full

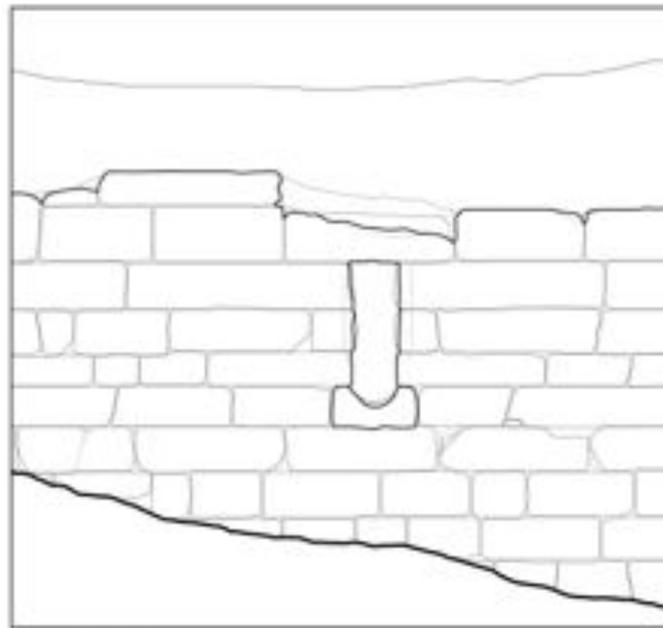
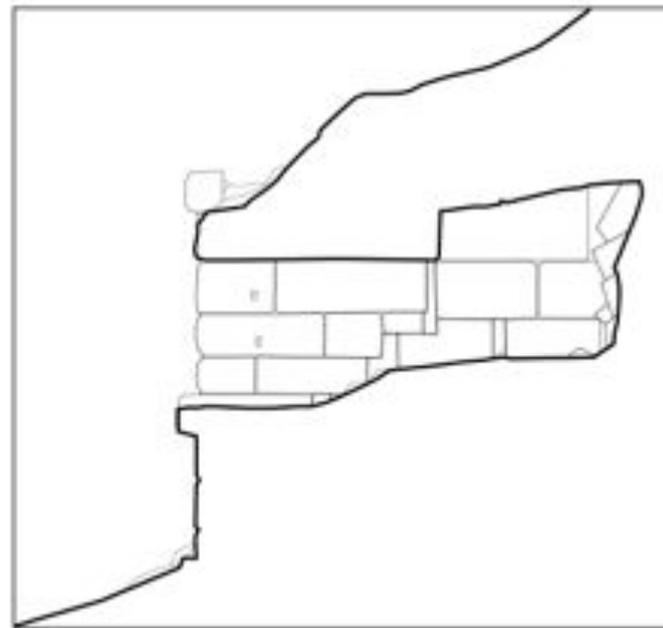
NOTION ARCHAEOLOGICAL SURVEY
BRICKS IN FORTIFICATION WALL (Drawing 1)

Fig. 4 Elevation and section of drain in north wall of fortifications

The entire circuit of the fortification walls was surveyed with a Real Time Kinematic Global Navigation Satellite System (RTK-GNSS). Select portions of the walls, especially on the north side, where the remains are best preserved but also most overgrown, were cleaned for study and photography. Architectural documentation of specific details was also continued. One feature of particular interest is a large drain in the south wall (see fig. 4)

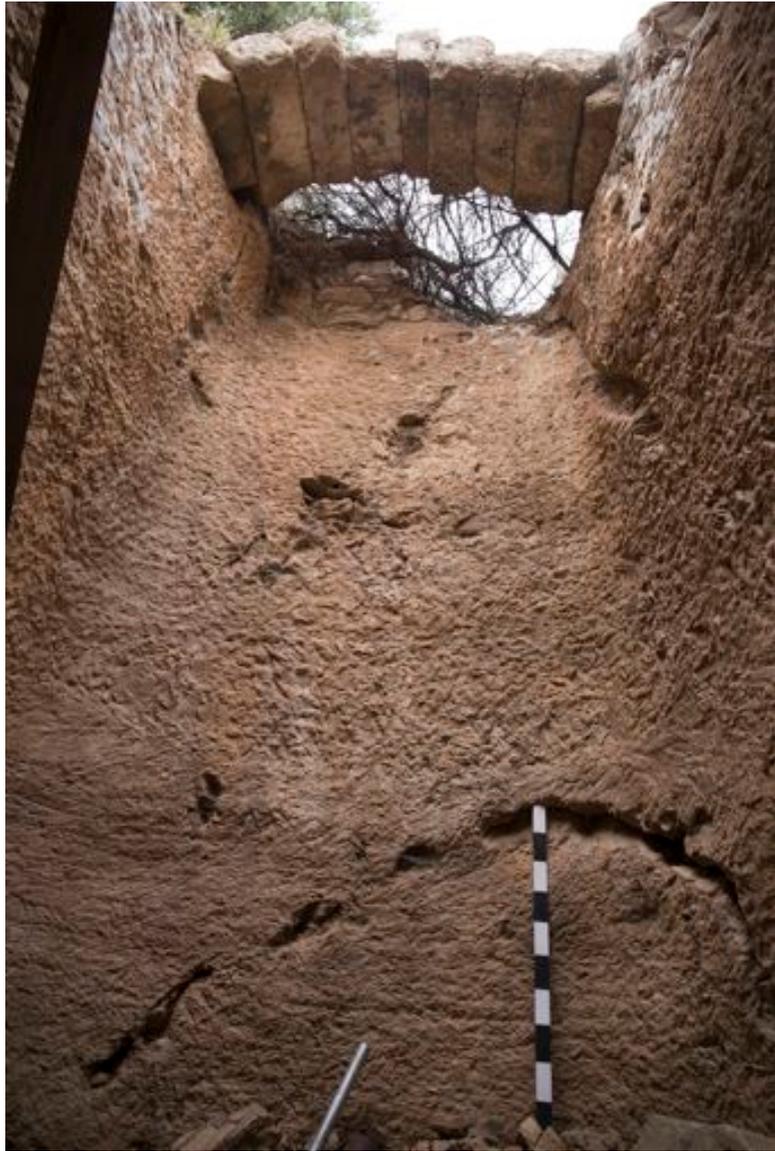
Fig. 5 View of interior of cistern

Eight of the 14 cisterns and probable cisterns noted in 2014 were measured, drawn, and photographed (see fig. 5). In addition, laser scans were made of two cisterns, producing detailed three-dimensional models (see fig. 6). All the cisterns were cut into the native rock, in some places schist, in others limestone, in still others, especially in the area of the Heroon, banded schist and limestone. As noted in last year's report, the cisterns are flask or bottle-shaped, with narrow cylindrical necks, widening out as they descend. In several cases, the upper parts of the necks are built out of rubble masonry, supporting schist or limestone cover slabs. Three of the best-preserved cisterns also feature two terracotta pipes situated opposite each other just below the level of the cover slabs. These presumably served to channel water running from roofs and drains into the cisterns. The interiors of the cisterns are sometimes but not always coated with a thick layer of hydraulic plaster, apparently routine in the case of cisterns dug into schist (to prevent loss of water through seepage into the rock), optional in the case of cisterns dug into the less permeable limestone.

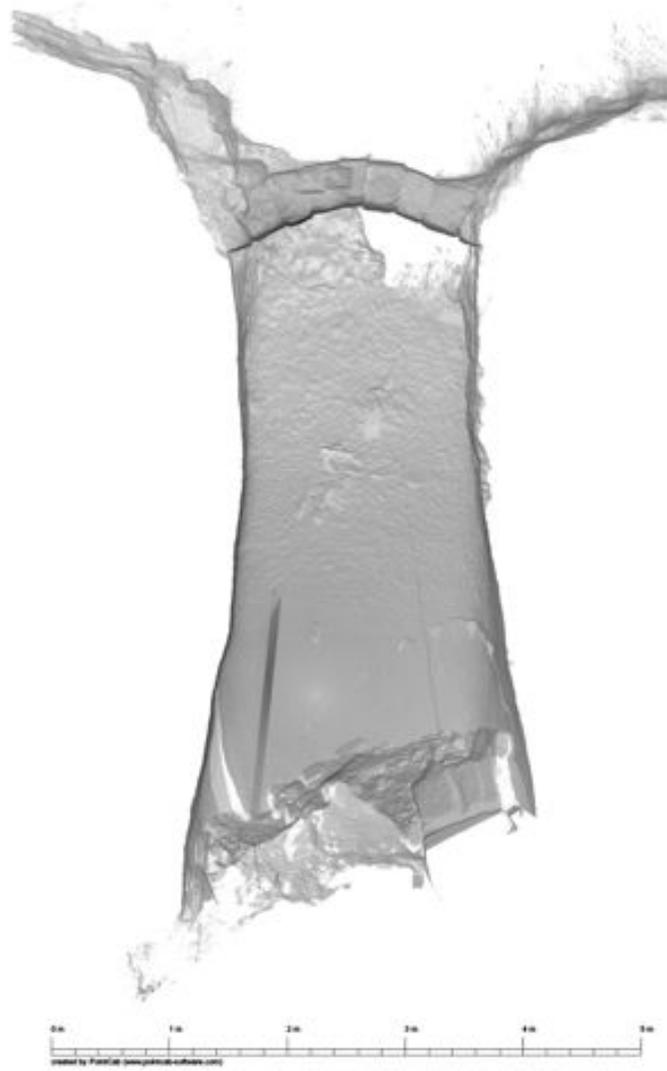
Fig. 6 Section of interior of cistern, produced by laser scan

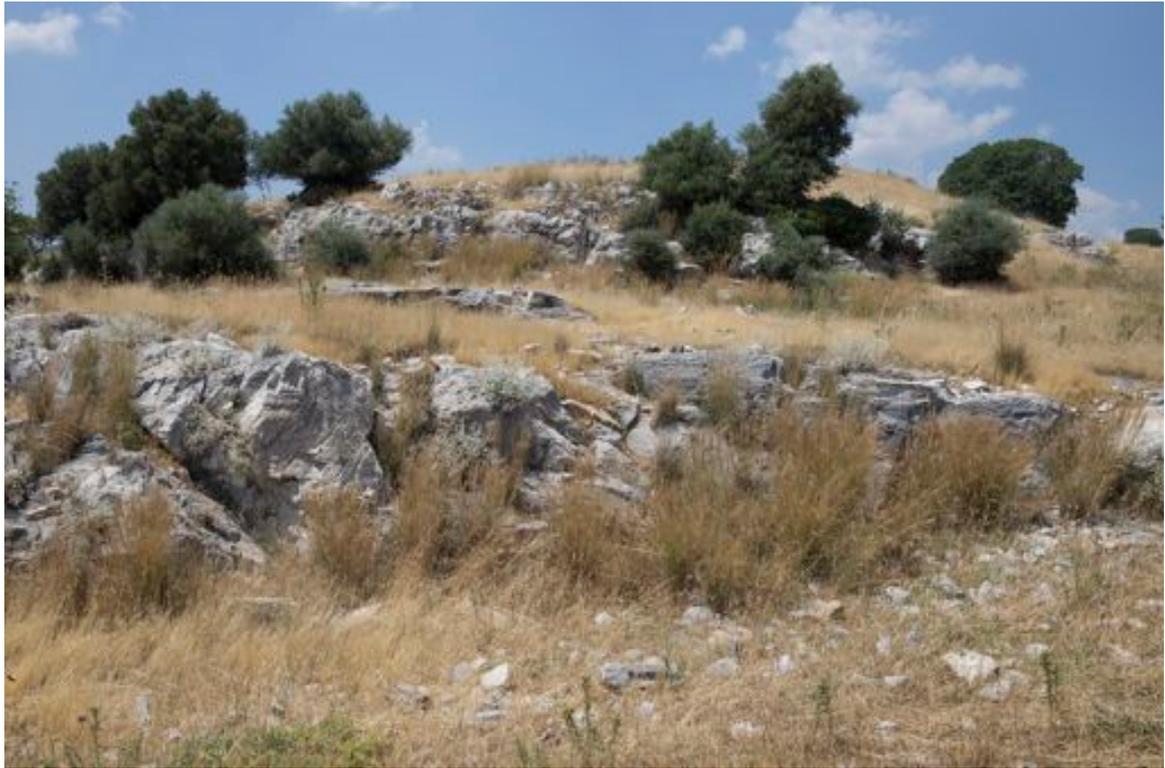
Fig. 7 View of quarry on west promontory

The bedrock of Notion consists of limestone, schist, and conglomerate rock. All three stones are used in the architecture of the site and were presumably, at least to a significant extent, quarried locally. A number of large quarry cuttings are visible, especially on the east and west promontories (see fig. 7). In addition, as noted above, the civic and sacred areas on the crown of the ridge that runs through the center of the city rest on broad level terraces hewn out of the native rock – they were thus in effect large open-area quarries. One puzzle is the source of the conglomerate rock used at Notion – the local outcroppings are not very extensive, and it is possible this stone was transported from other sources to the north or east.

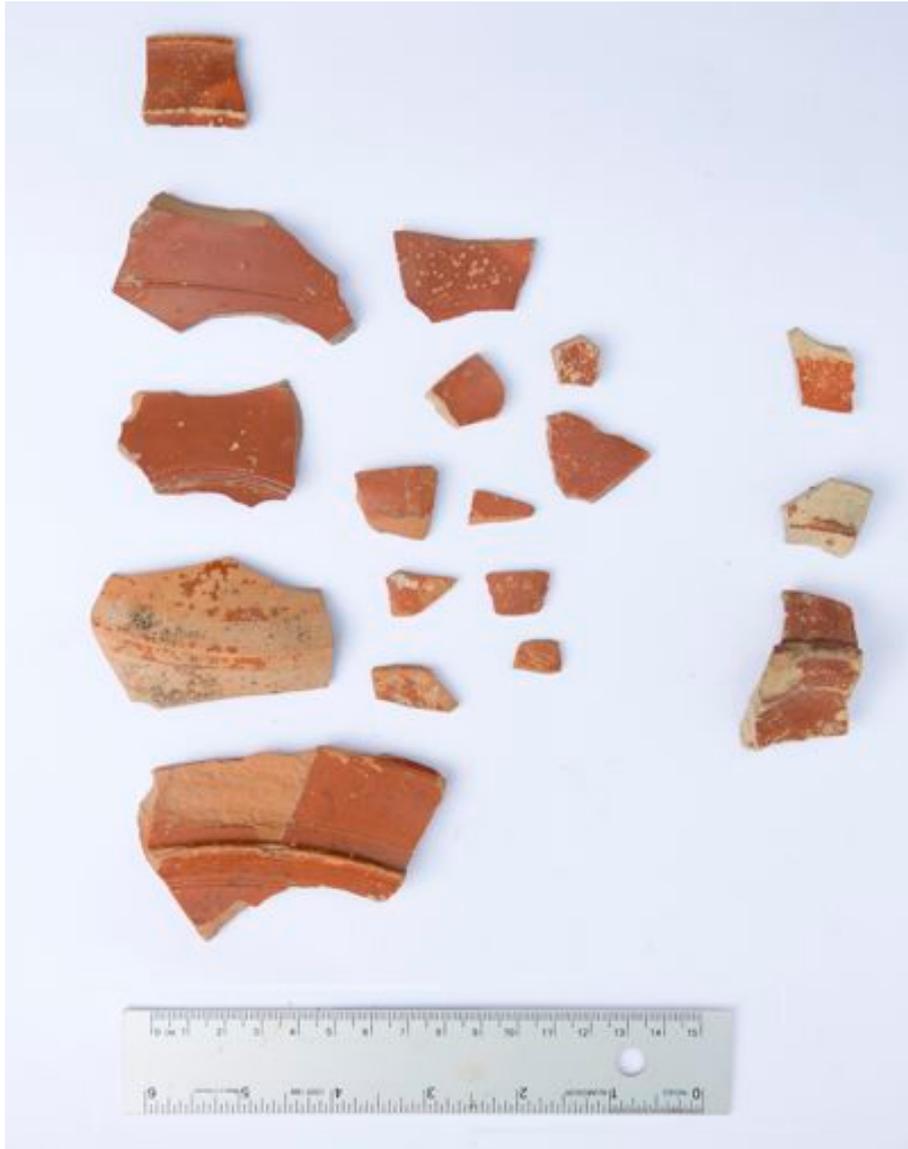
Fig. 8 Selection of late Hellenistic and Augustan sherds

Finds were then sorted in the field into five basic categories: tiles, coarse body fragments, coarse diagnostics (rim, handle, or foot fragments), fine body fragments, and fine diagnostics. Weights were taken of all the pottery and all the tiles, and all the finds from each square were photographed as a group. The tiles and body fragments were then re-deposited in the 30 X 30 m square to which they belonged. The diagnostic pottery was taken back to the excavation camp, washed, sorted, classified, and photographed – and then also re-deposited in the 30 by 30 m square in which it was originally found. On June 11, a selection of the pottery was examined by ceramicists Gül Gürtekin Demir and Sabine Ladstätter. It is remarkable that none of the pottery seems to predate the 3rd century B.C. or to postdate the 1st century B.C. The fine wares include typical late Hellenistic and Augustan wares such as mold-made bowls, lagynoi, Augustan relief ware, ESA, and early ESB – but no later ESB (see fig. 8). The amphorae also appear to be exclusively Hellenistic.

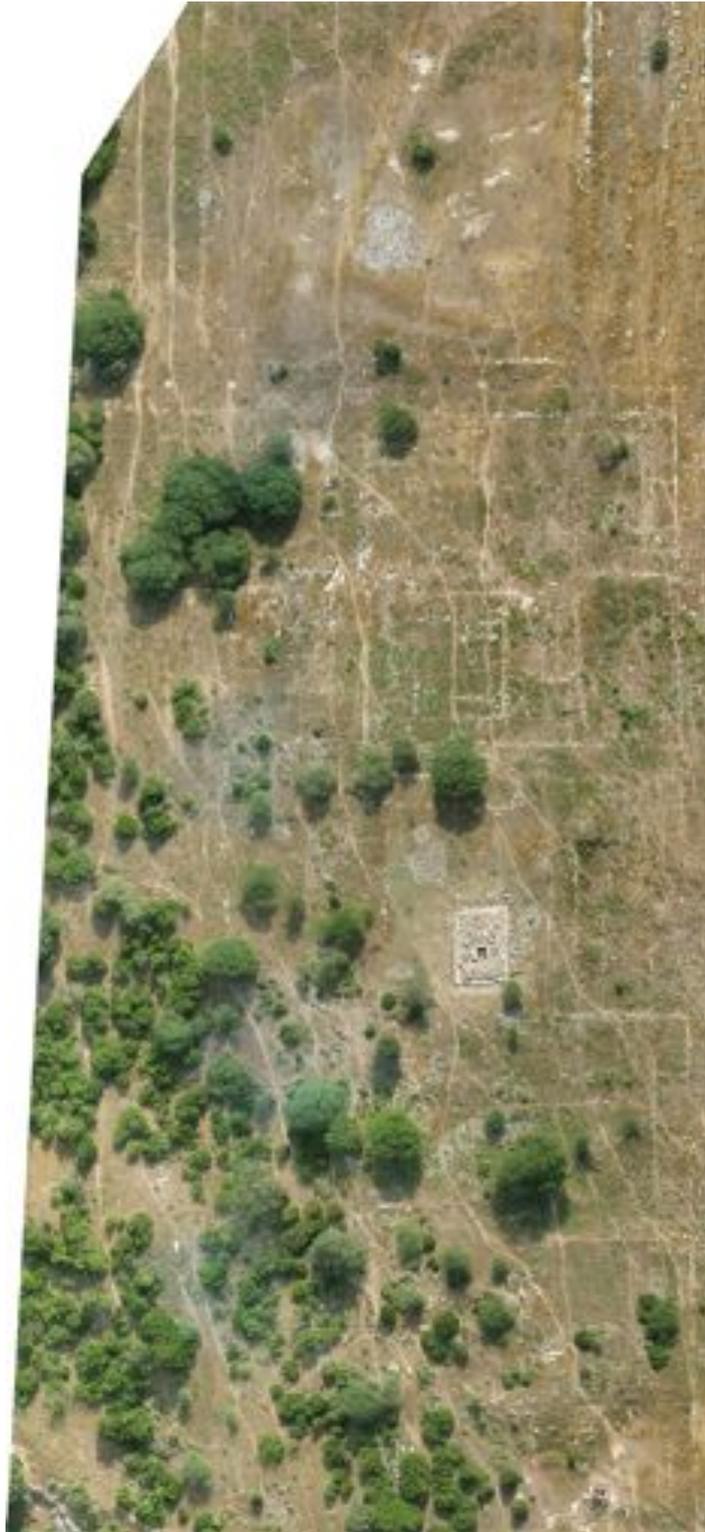
Fig. 9 Orthophoto of Heroon and adjacent areas

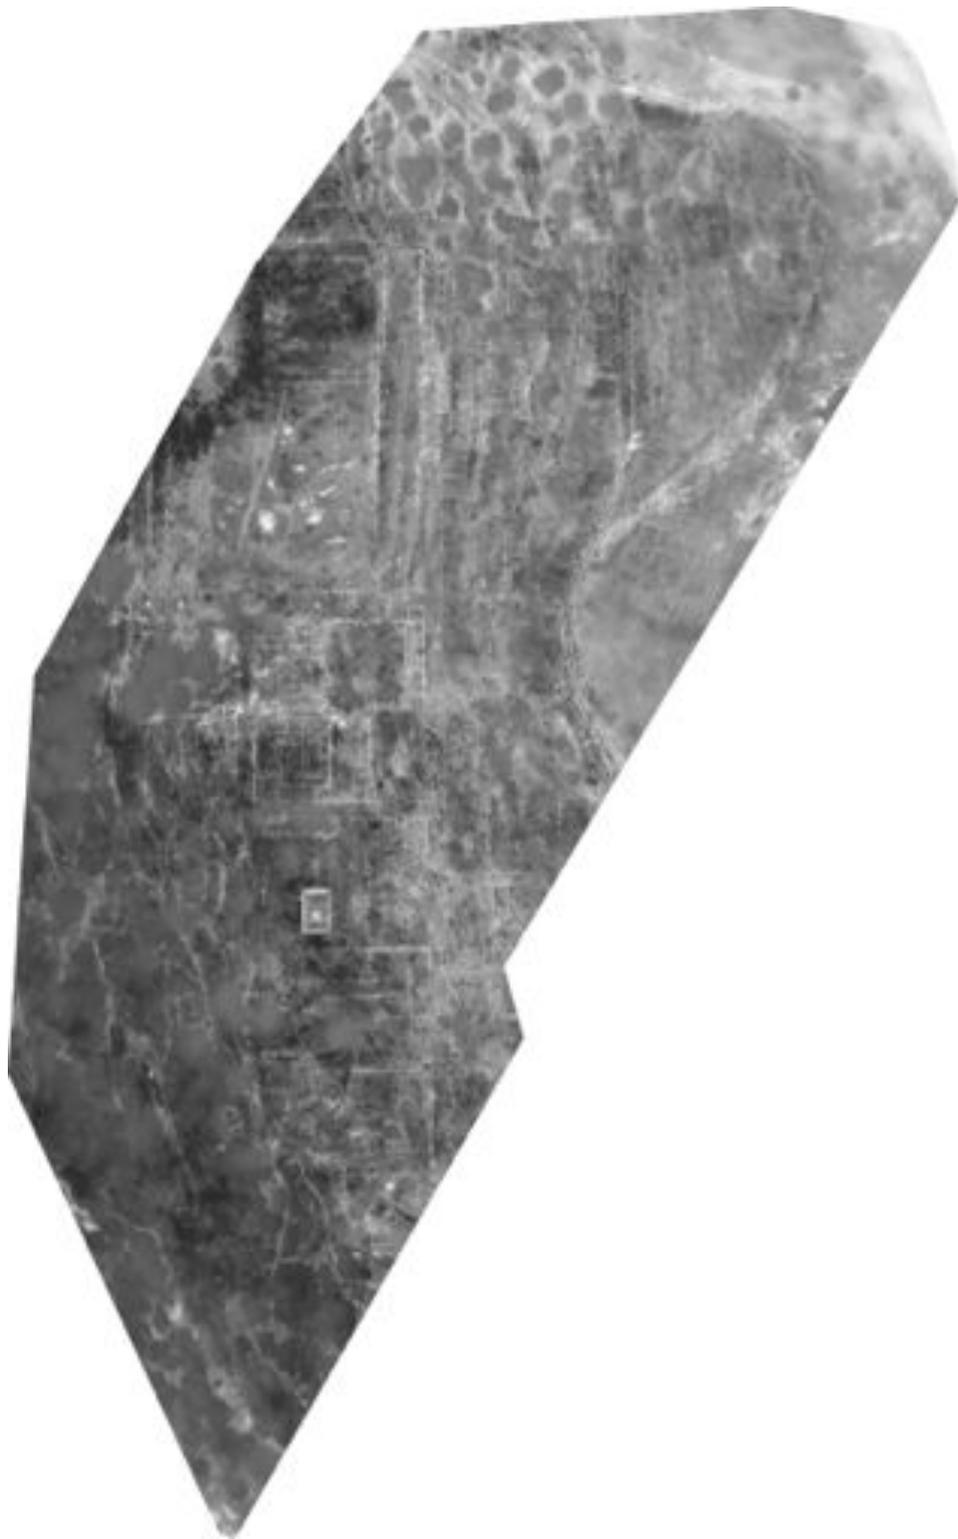
Fig. 10 Thermal image of center of city

Between June 6 and June 9, a program of aerial survey of the site was carried out by Alexey Gribovskiy and Cesar Serrano Montero, using lightweight drones manufactured by the Swiss company SenseFly. Aerial photographs were made of the entire site; these photos were then used to construct a digital elevation model, which have in turn been used to generate ortho-rectified images to aid in mapping the architectural remains of the site, as well as detailed contour maps (see fig. 9). In addition, select parts of the site were surveyed at dawn with a thermal sensor. Since stone retains heat for longer than earth, this provided a very effective way of mapping stone structures partially or largely buried under the earth (see fig. 10).
